EXERCISE DESERT ROCK LAS VEGAS NV

EXERCISE DESERT ROCK V. JANUARY-JUNE 1953. VOLUME I. OPERATIONS--ETC(U)

Exercise Desert Rock V

Volume I - Operations

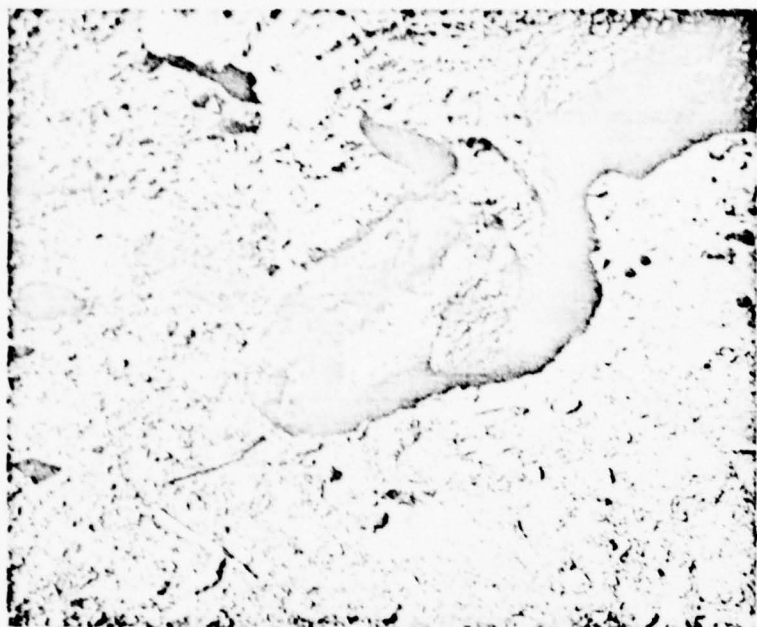
C-2 at 1000 yds. This is a close-up of the preceding sheep shortly before death.

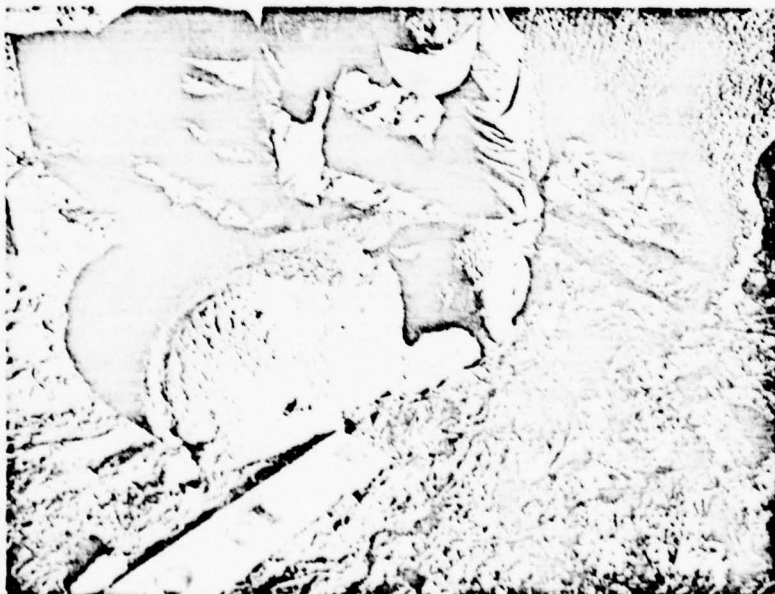
C-3 at 1000 yds. Second degree burns on the face and extensive wool burns. Death occurred 26 Mar. and was attributed to acute lethal radiation sickness.

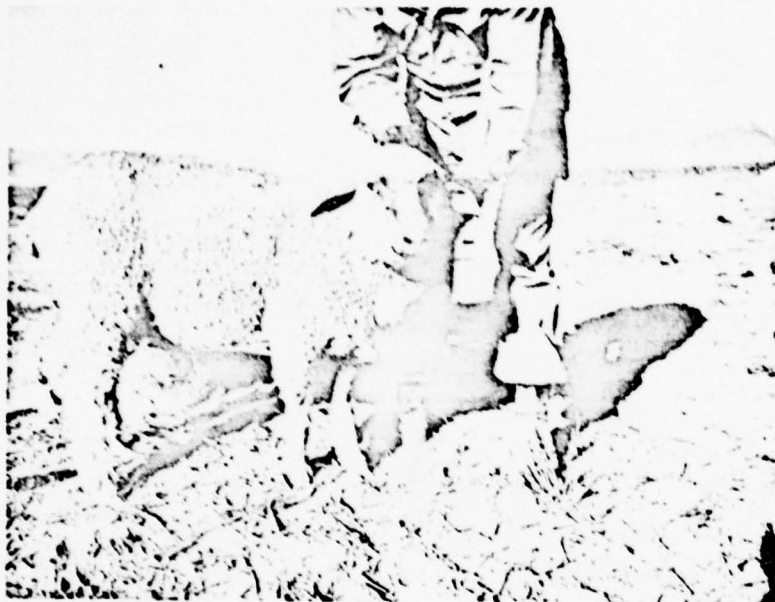
C-1 at 1000 yds.
This sheep suffered
third degree burns
on the face and ex-
tensive wool burns.
It became prostrate
from blast effects
the afternoon of the
detonation and was
destroyed to prevent
further suffering.

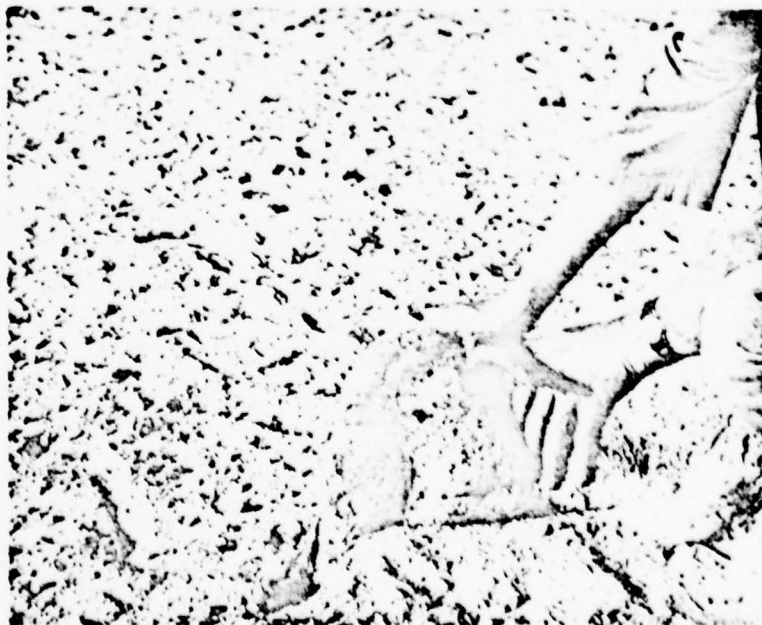
C-4 at 1000 yds. This is a picture of the above animal taken shortly before death. Note the third degree burns on the face and ear.

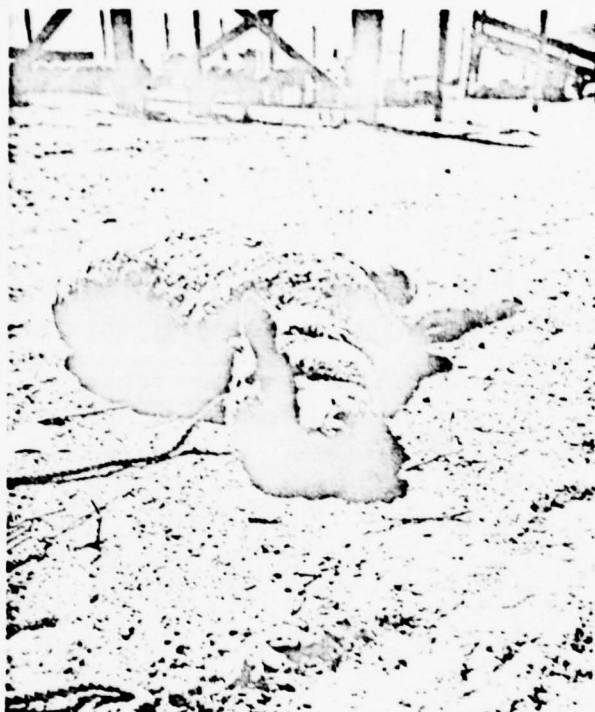
C-3 at 1000 yds. This is a picture of the preceding sheep taken after death. From all outward appearances there was little wrong with this animal.

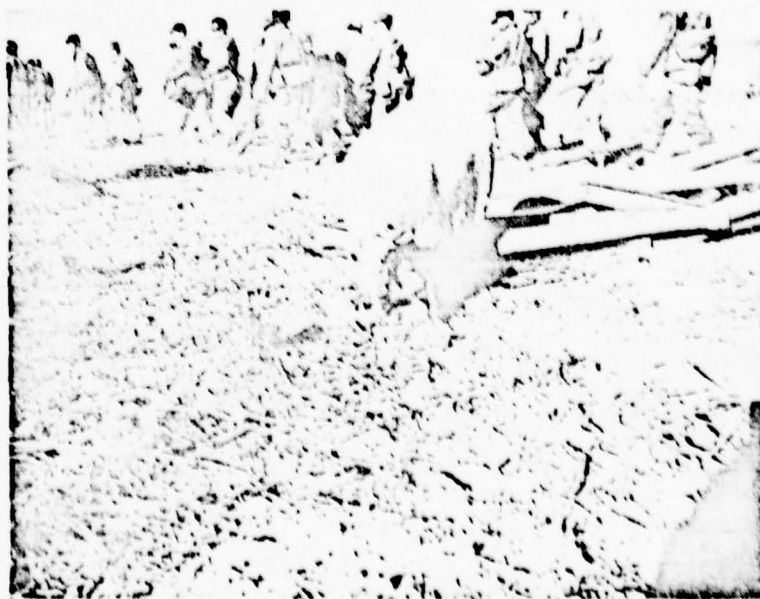
C-3 at 2000 yds.
This sheep had second degree burns on the face. Note collapse of sheep pens.

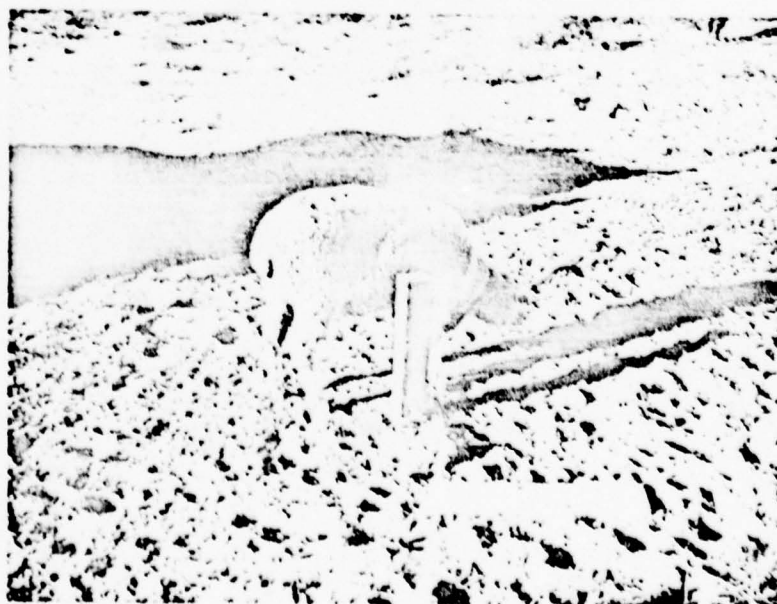
C-1 at 2000 yds. The sheep at this position had extensive wool burns across the back and one side.

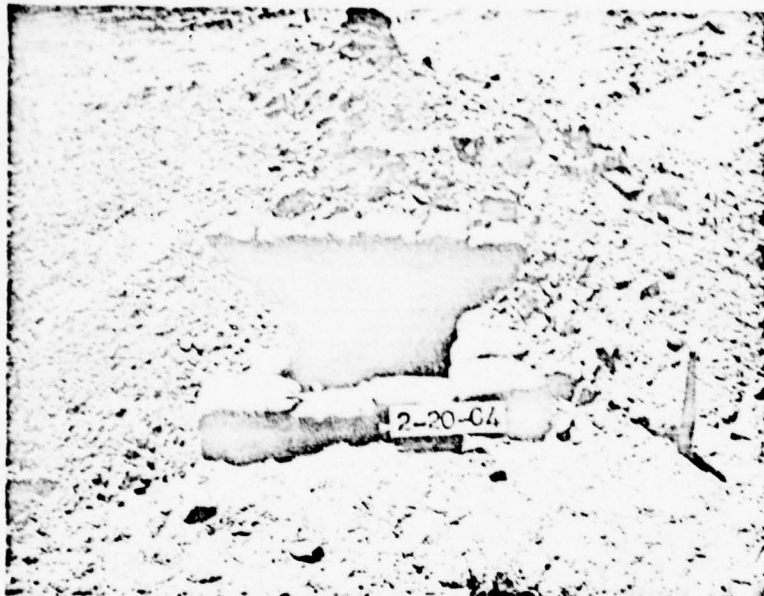
C-4 2,000 yds. Bunker
facing GZ.

C-4 2,000 yds. All
sand bags destroyed.

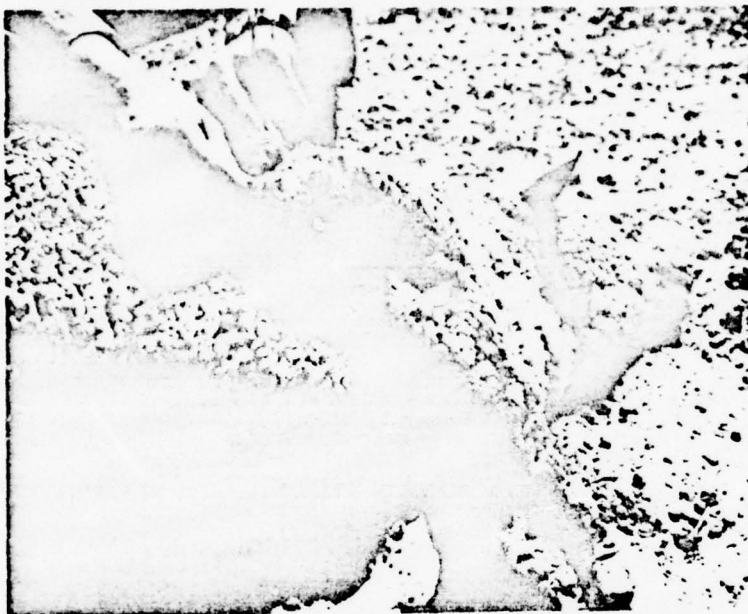
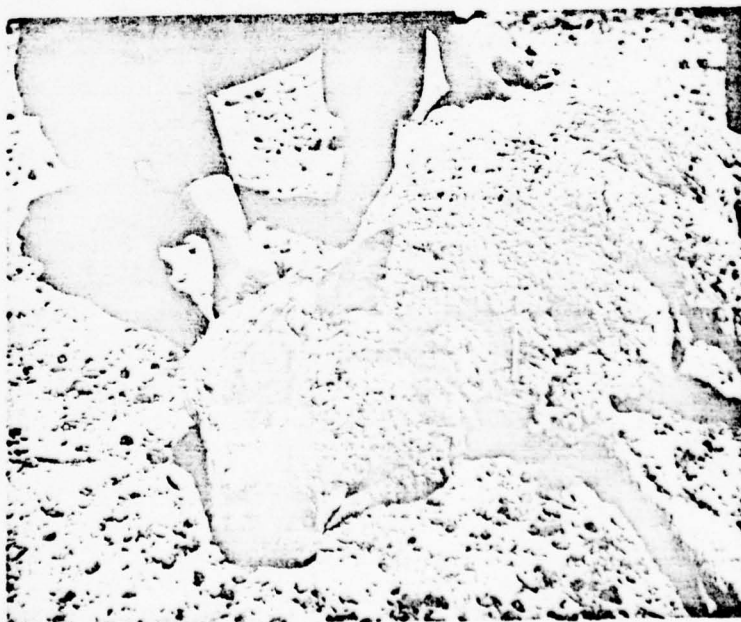
C-1, 1000 yds. This is a picture of the preceding animal showing the wound received. Death occurred 19 April and was attributed to radiation sickness.

C-1, 1000 yds. This is another view of the above sheep showing the third degree burns on the face.

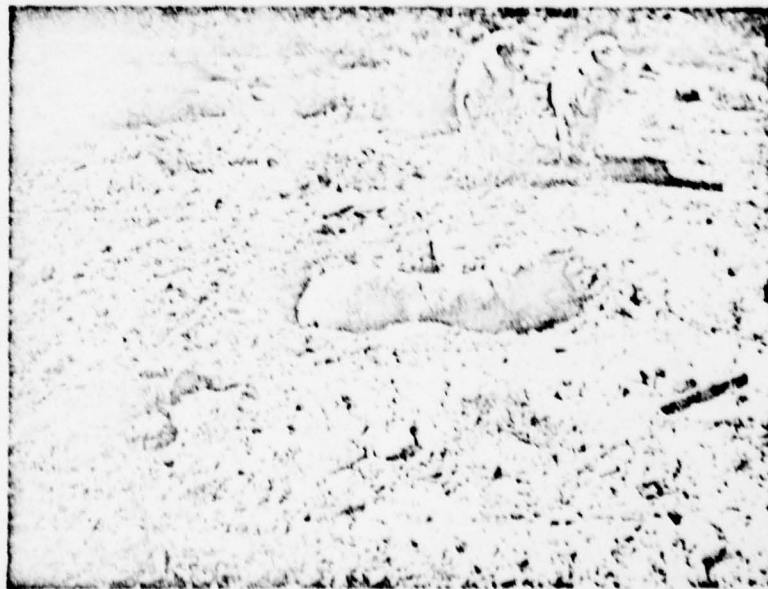
C-1 2500 yds. The sheep with the wool burns was staked at position C-1, 2500 yds and the one beside it was at position C-2, 2500 yds. The sheep at position C-2 showed no visible effects. Both sheep pulled their stakes from the ground shortly after the detonation.

C-2, 2000 yds. The sheep in the foreground was at position C-2, 2000 yds, and was normal. The one on the left suffered slight wool burns, and was from C-1, 2000 yds. The one on the right was normal, and was from C-2, 2000 yds.

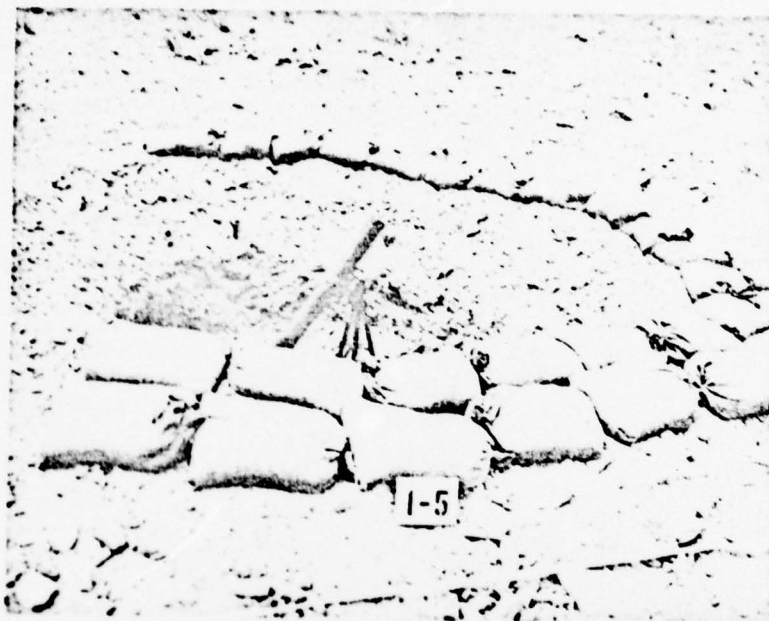
81 MM mortar in em-
placement 550 yards
from GZ.

Tube detached from
base plate and
thrown half out of
emplacement. Bipod
damaged.

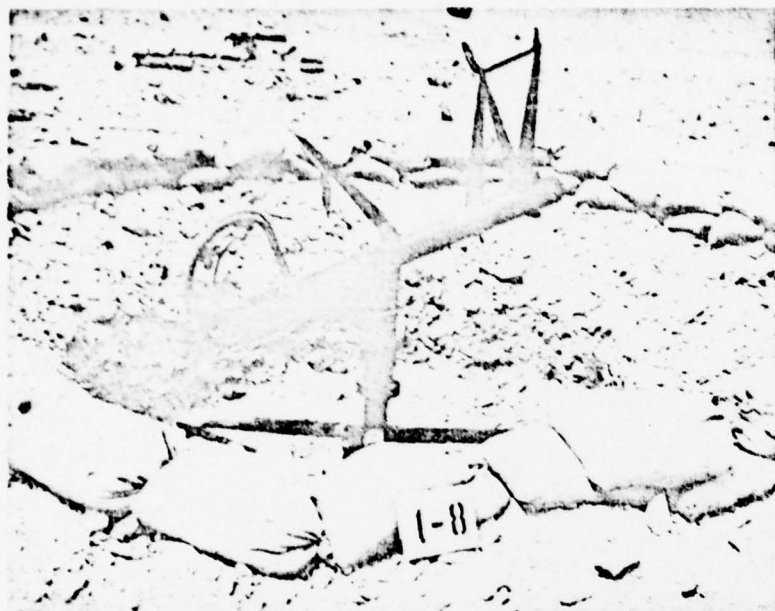
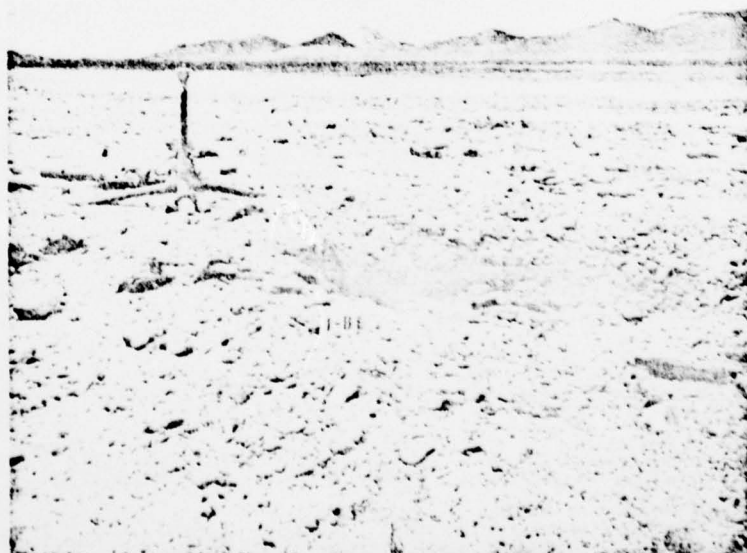
Machine Gun Cal. 50,
AA, dug in 550 yards
from GZ.

Blown out of emplace-
ment and destroyed.

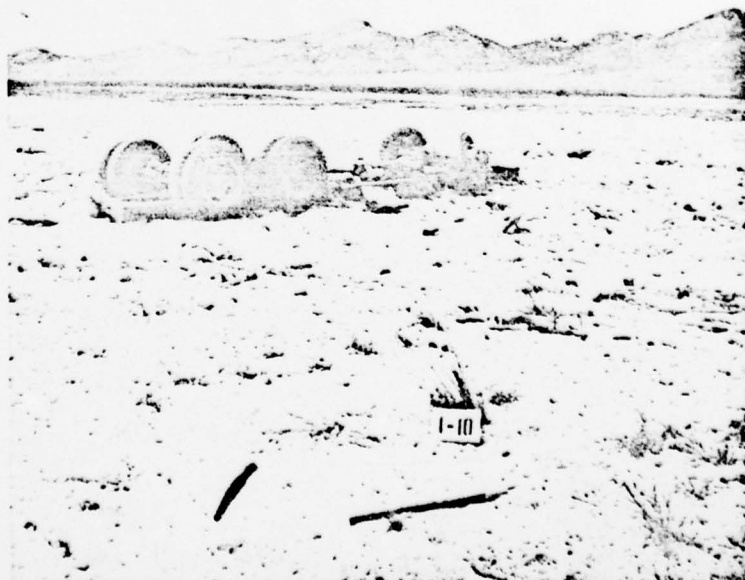
Truck, 2½ ton, 380
yards from GZ.

Thrown approximate-
ly 150 feet and de-
molished. Wreckage
in pieces.

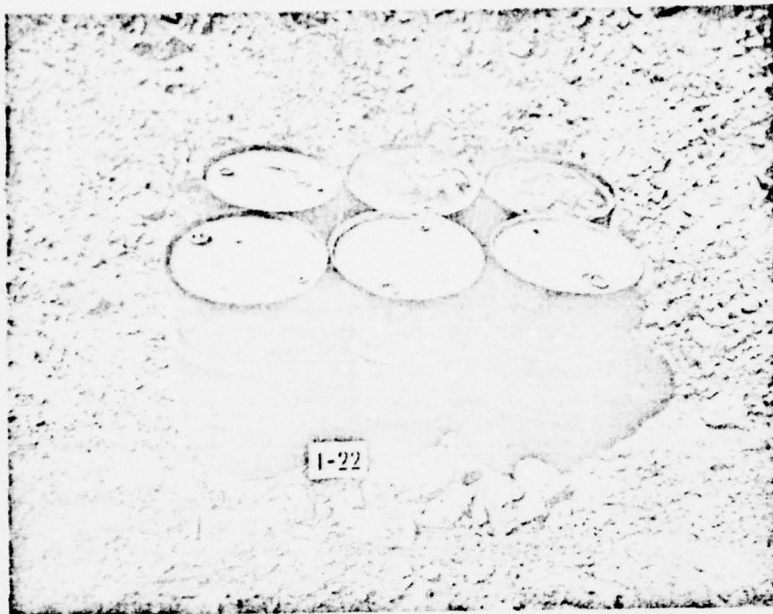
Fuel dump (6-55 gallon drums of gasoline) dug in, drums on end 650 yards from GZ.

Dump partially buried but intact. Gasoline did not ignite.

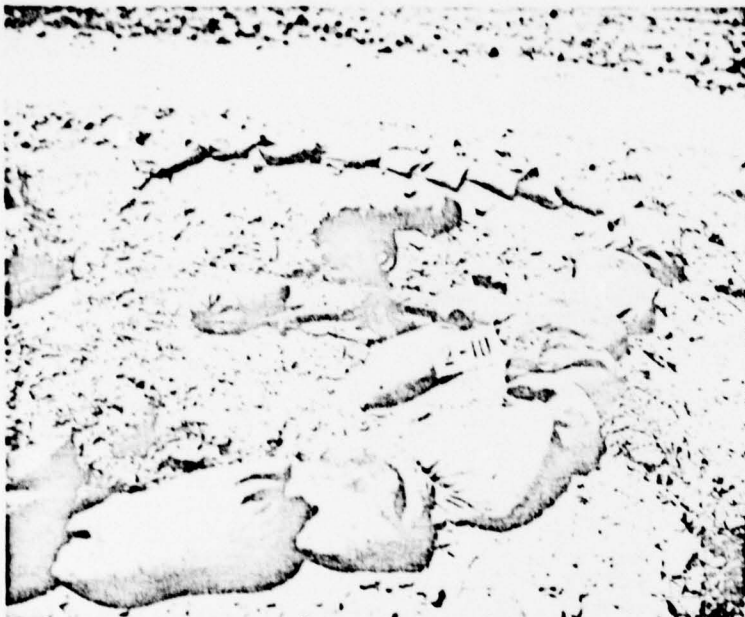
2-10

Machine Gun, Cal 30
M1917A1, dug in at
1015 yards from GZ.

Gun swung 180 degrees
and muzzle depressed
to ground. Apparently
undamaged.

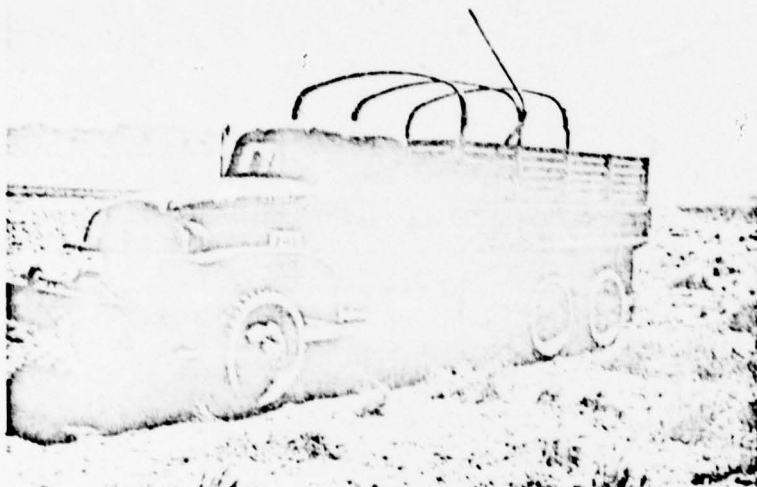
Truck, 2½ ton, 1025
yards from GZ.

Thrown 45 feet, over-
turned. Severely da-
maged.

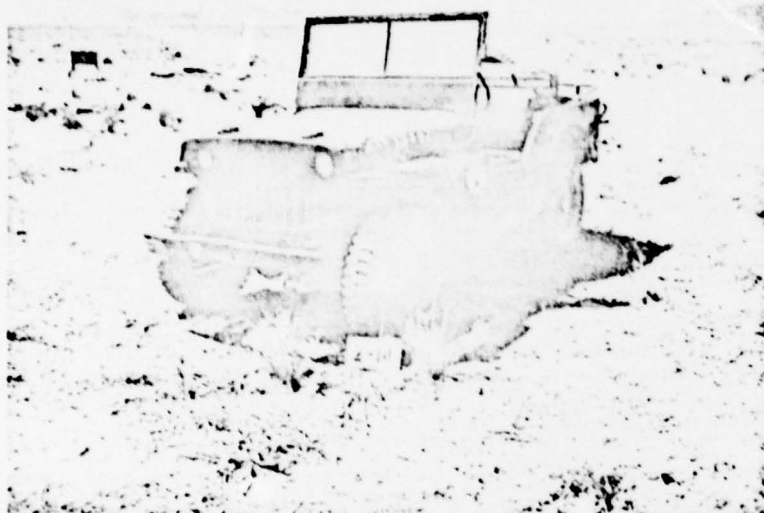
Truck, $\frac{1}{4}$ ton 1025 yards
from GZ.

Thrown 40 feet and
overturned. Severely
damaged.

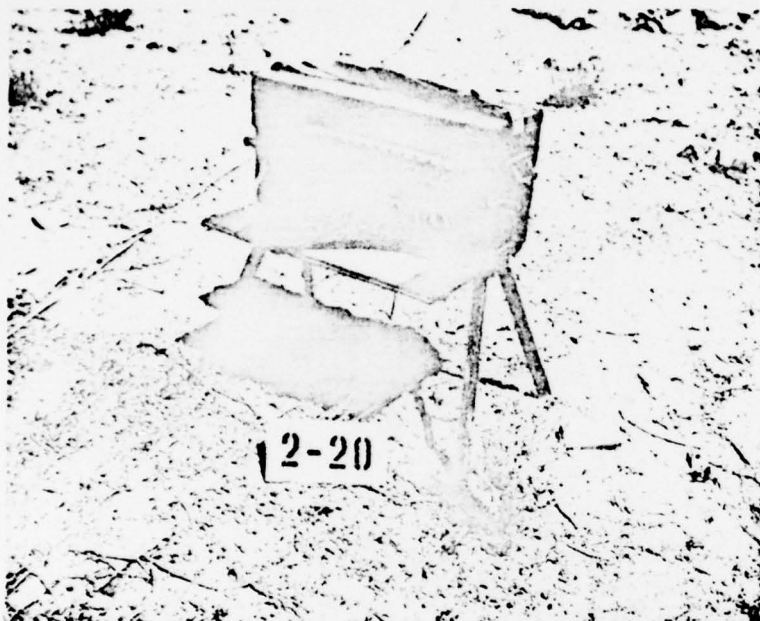
Switchboard, ED-72,
standing in open
1050 yards from GZ.

Thrown 30 feet and
damaged beyond re-
pair.

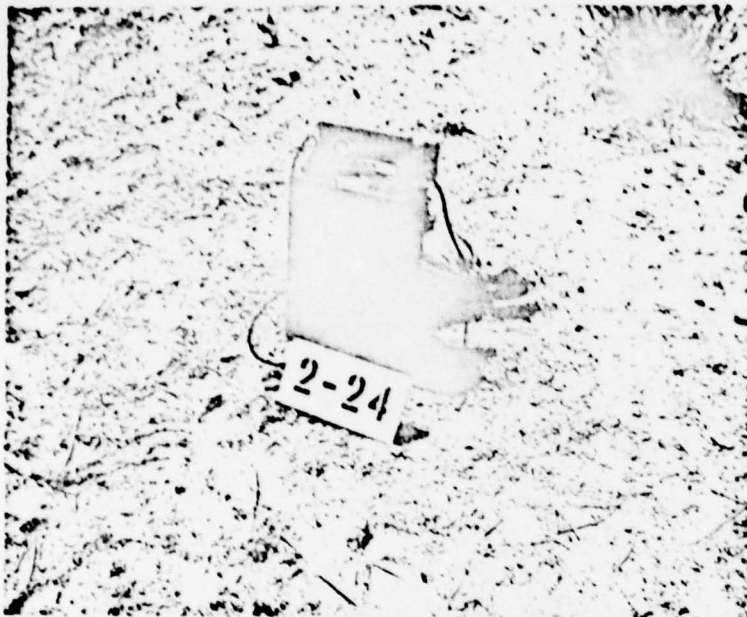
Radio, SCR-300,
standing, propped
by sandbag 1060
yards from GZ.

Thrown 90 feet. Se-
verely damaged.

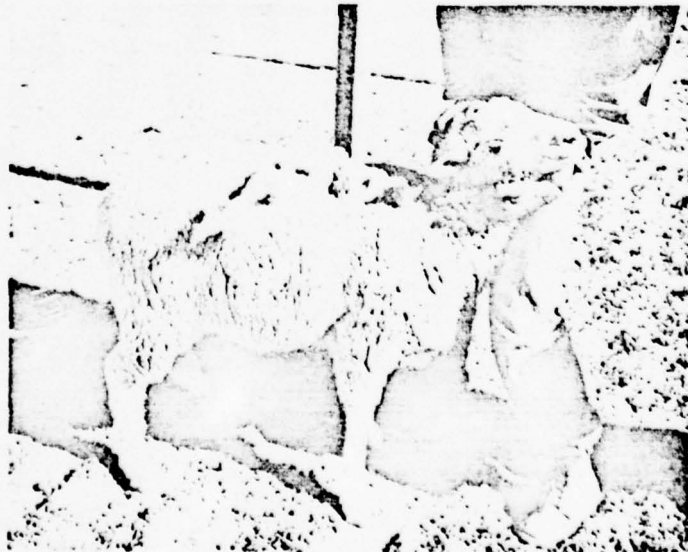
1,500 yards - 6 feet trench. This sheep initially suffered no visible effects from the detonation. Epilation commenced 10 May and can be seen in the picture.

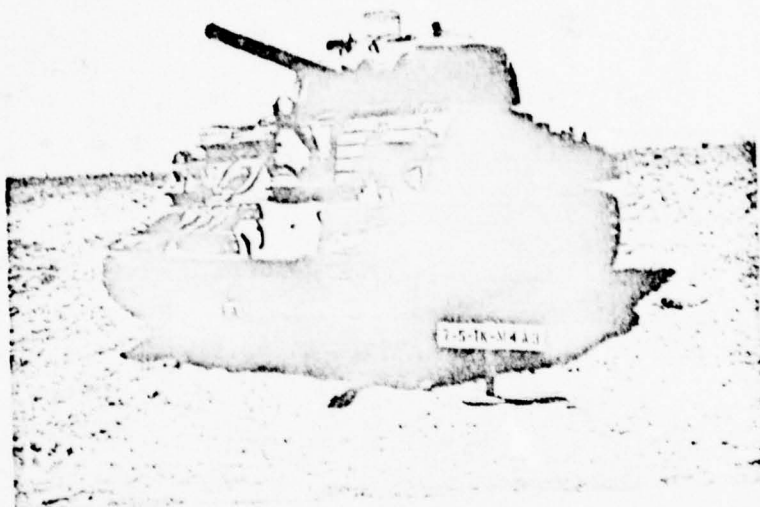
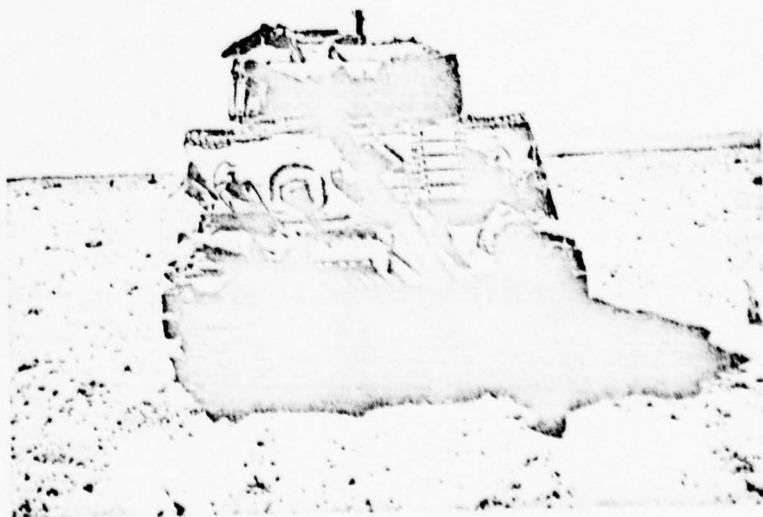
Tank, Medium, M4A3,
facing GZ at 500
yards.

Destroyed beyond re-
pair. Turret blown
loose but still on
top of tank. Vehicle
was moved back about
20 feet and badly
burned.

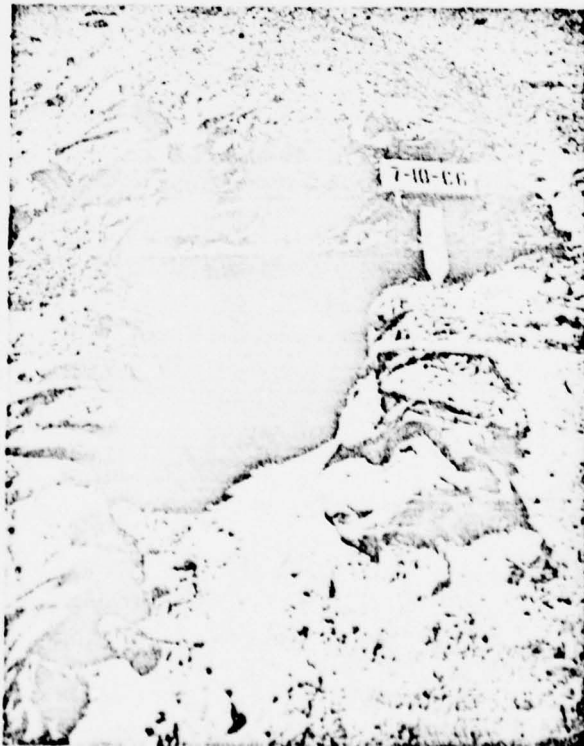
C-6 Bunker at 1000
yards from GZ.

All sandbags destroyed and rear
wall caved in.

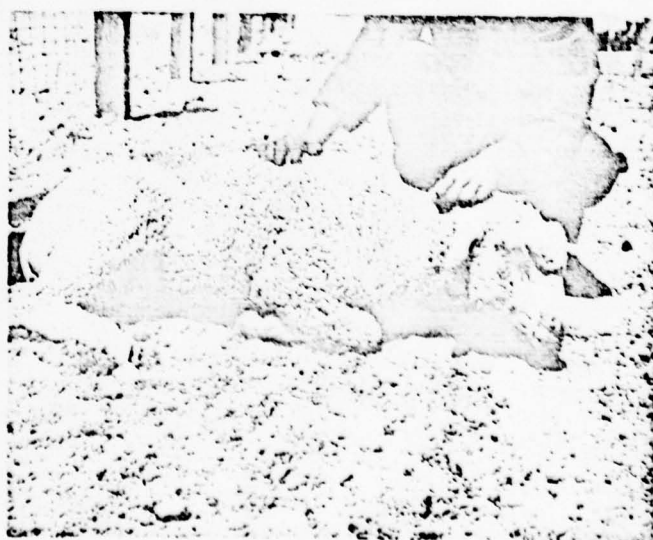
C-7 1000 yards. 3rd degree burns of face and ears. Extensive wool burns. Destroyed 21 May to prevent suffering. Received dosage of 71 r.

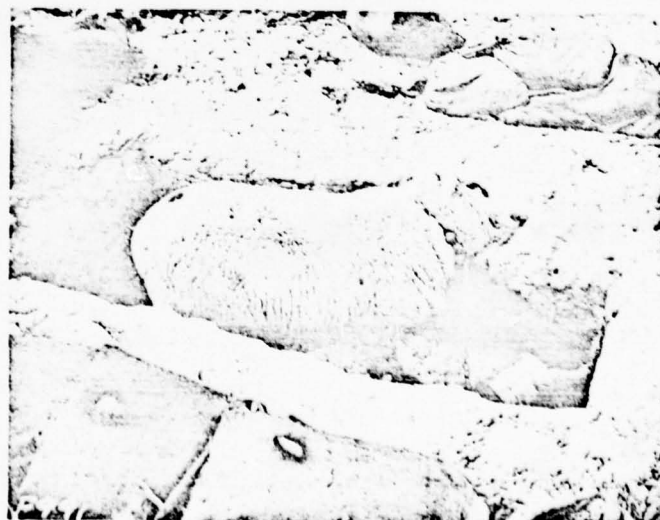
C-8 1500 yards. No vi-
sible effects. Dosimeter
reading lost.

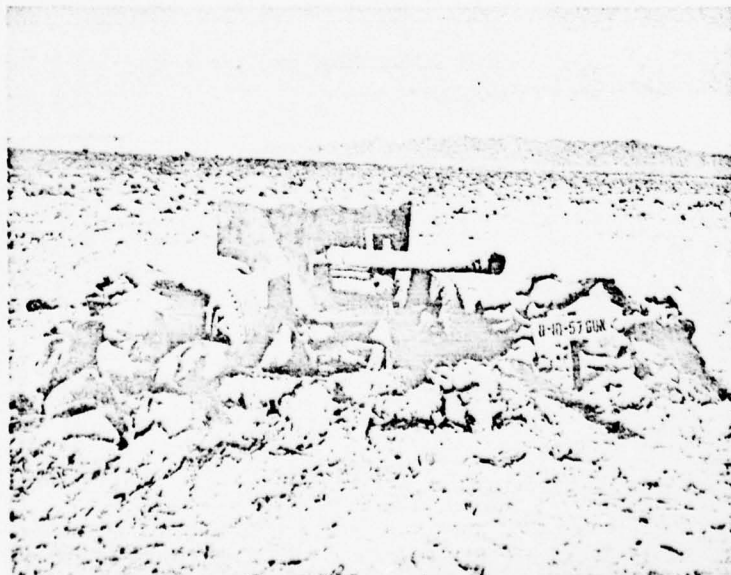
57mm Gun facing GZ at
1000 yards. Gun is in-
side sandbag revetment.

Weapon slightly scorched.
Revetment destroyed in
front and revetment mat-
erial blown on gun.

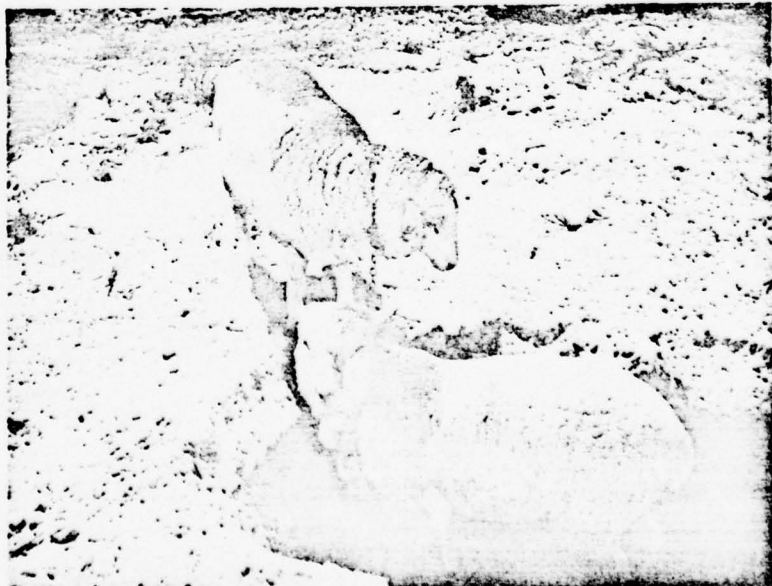
C-1 & C-2 2000 yards. Both animals show 2nd degree burns on the face and ears with moderate burns on the back. They will apparently recover from the effects of the detonation.

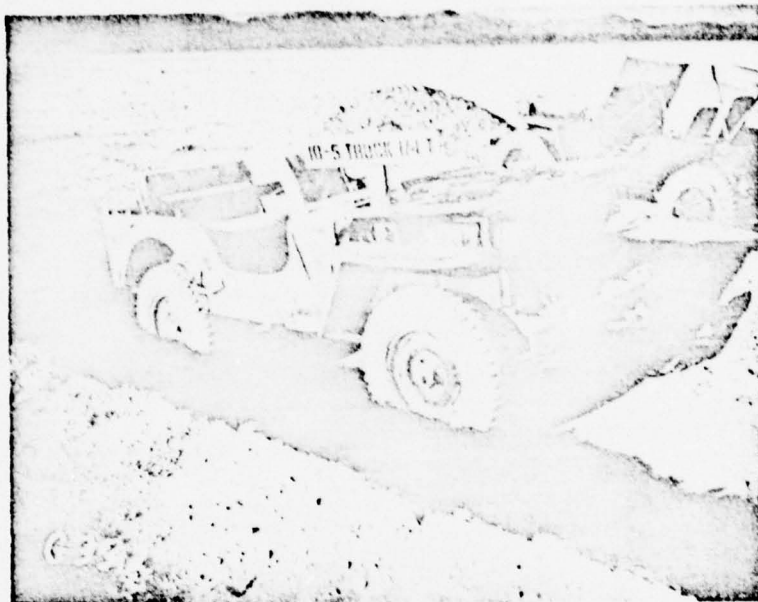
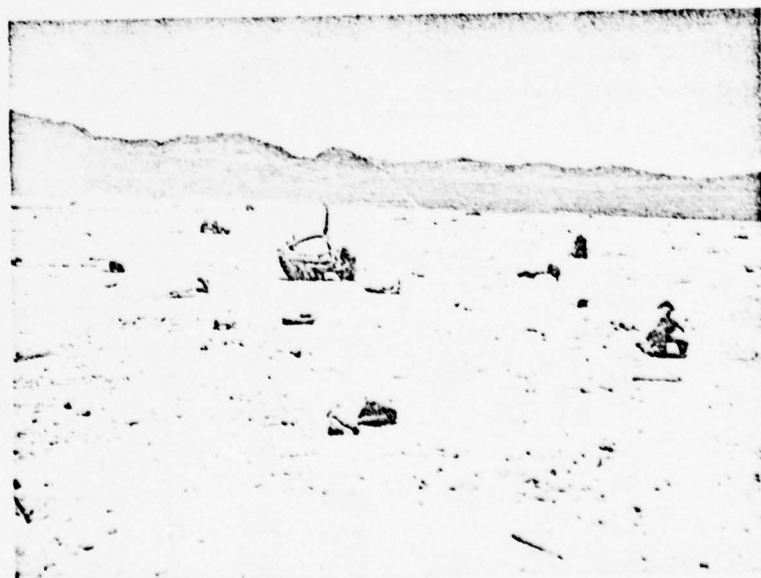
Truck 1/4 ton 4 x 4
M-38 facing 45 de-
grees right of GZ
at 500 yards.

Completely destroyed.

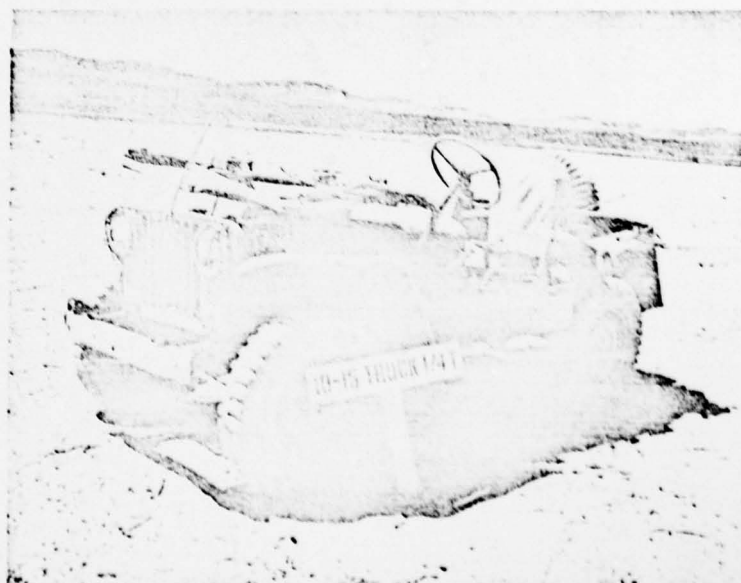
Hood torn off and blown
50 feet to rear. Paint
burned.
